Technical Service BULLETIN

M.I.L. "ON" DTC P0171, P030#, AND/OR P0133 ENGINE RUNNING LEAN IN SUBFREEZING AMBIENT TEMPERATURES

'03 – '08 Corolla & Matrix (1ZZ-FE)

ENGINE
EG045-07

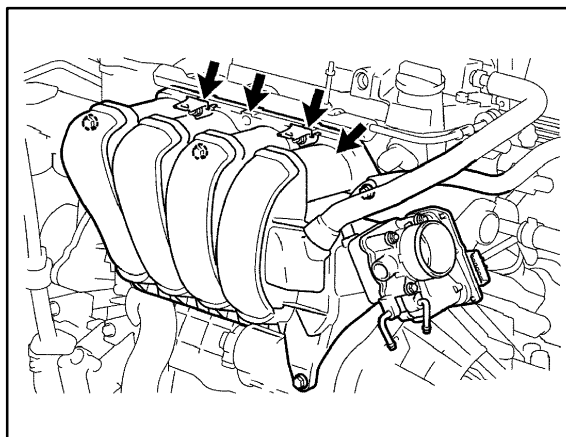
2. Following conventional diagnostic procedure, confirm if there is a leak where the intake manifold and cylinder head meet between each intake runner.

3. Did the short term fuel trim change to a rich reading (negative fuel trim) in step 2?
 - If **YES** — Replace the intake manifold gasket.
 - If **NO** — Check for other vacuum leaks or lean running conditions per the Technical Information System (TIS).
