**NUMBER:** 25-005-13 REV. A

I/M Readiness Check Continues To Indicate OBD System Is Not Ready For I/M Testing (X51 Lifetime Warranty Extension)

2005 - 2006 (TJ) Wrangler

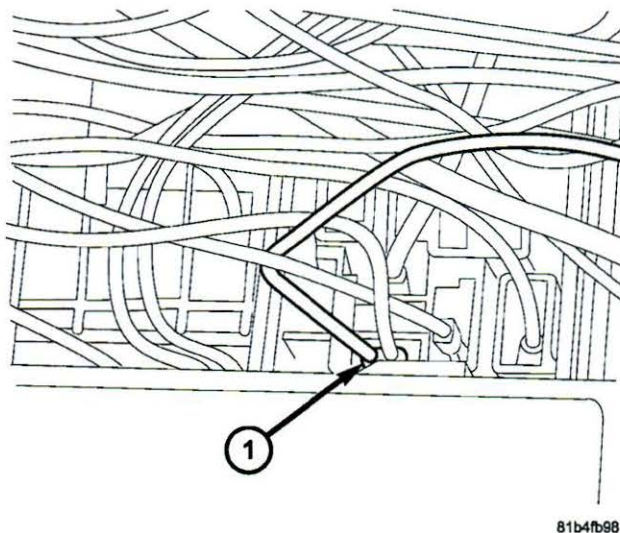
**Fig. 1 TWO 20 GA. PK WT WIRES IN CAVITY A13**

1 - TWO 20 GA. PK/WT WIRES - AT PDC CAVITY A13 (FOR ASD RELAY PIN 85)

1. Remove and isolate the positive and negative battery cables from the battery.
2. Remove the Power Distribution Center (PDC) cover from the PDC.
3. Locate the ASD (Auto Shut Down) and the Fuel Pump relays in the PDC.
4. Remove the two nuts used to secure the positive battery cable to the PDC. Remove the positive battery cable from the PDC.
5. Remove the PDC from its bracket and remove the cover from the bottom of the PDC to expose the underside wiring.
6. Locate the terminal end in PDC cavity A13 that connects to the ASD relay pin 85. Two 20 gauge wires, each of PK/WT color, are crimped to this terminal end (Fig. 1).

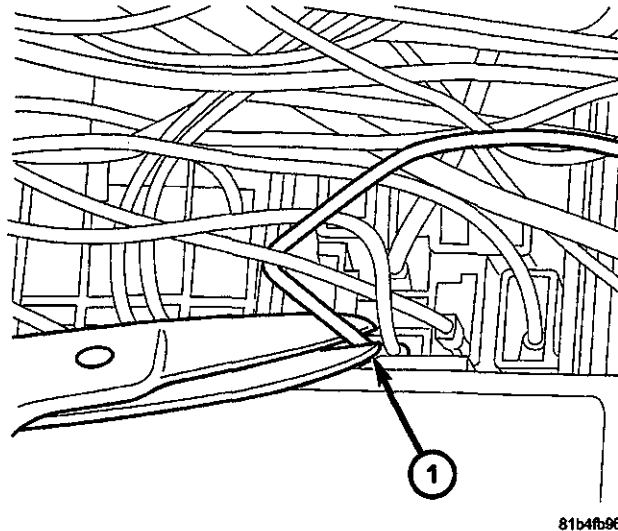
**Fig. 2 CUT ASD 20 GA. PK WT TO FUEL PUMP**

1 - CUT PDC CAVITY A13 PK/WT WIRE THAT GOES TO THE FUEL PUMP RELAY CLOSE TO TERMINAL

7. At PDC cavity A13 (ASD), locate the one PK/WT wire that connects to the fuel pump relay terminal.
8. Cut the PK/WT wire, that connects to the fuel pump relay, as close to the PDC cavity A13 terminal as possible (Fig. 2).

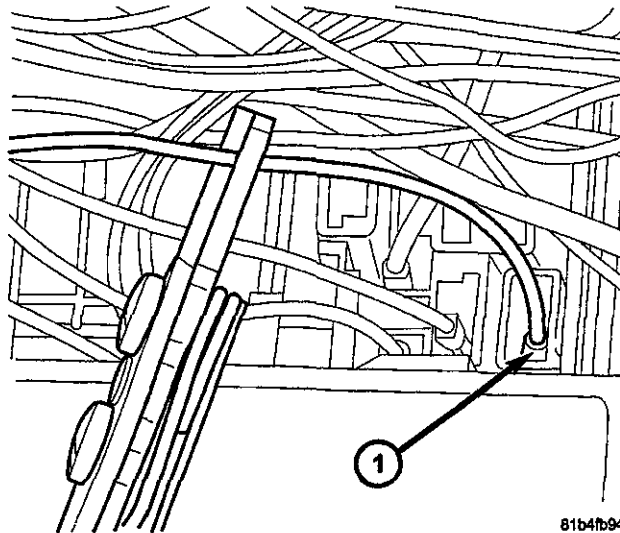
**Fig. 3 CUT ASD 18 GA. RD YL WIRE IN CAVITY A15**

1 - CUT PDC CAVITY A15 18 GA. RD/YL WIRE THAT GOES TO ASD RELAY PIN 30 TWO INCHES FROM TERMINAL

12. Locate the RD/YL 18 gauge wire connected to the terminal end in PDC cavity A15. This wire connects the ASD relay pin 30 to fuse #9 (ASD power) in the PDC.
13. Cut this wire approximately 2 inches from the PDC cavity A15 terminal (ASD relay pin 30) (Fig. 3).

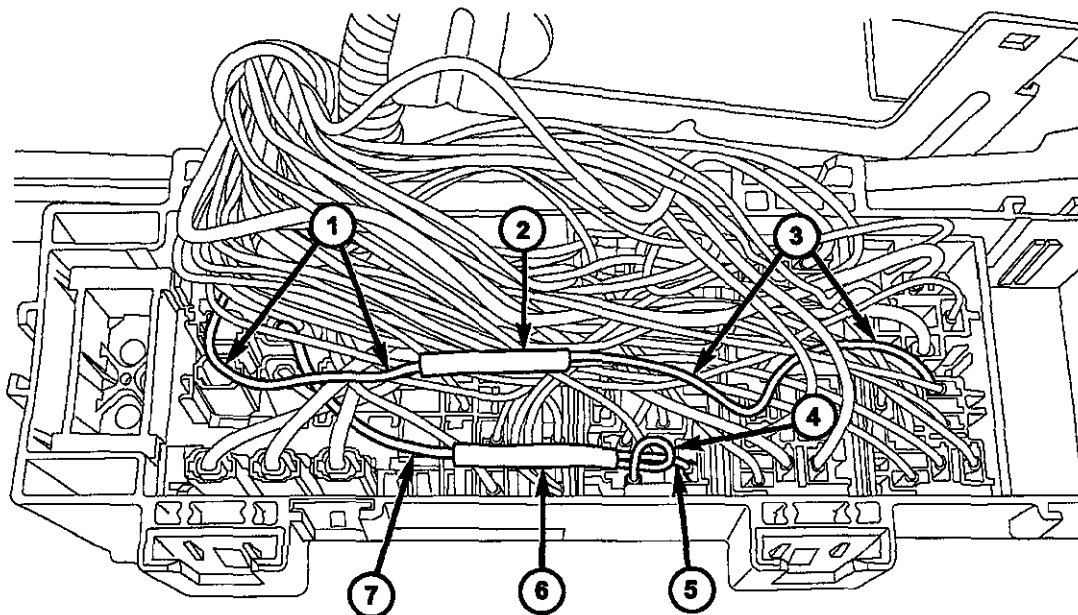
**Fig. 4 COMPLETED WIRE SPLICES**

- 1 - 20 gauge PK/WT wire from wire harness bundle with convolute
- 2 - Splice repair (2 wires)
- 3 - 20 gauge PK/WT wire from fuel pump relay
- 4 - 20 gauge PK/WT wire from PDC cavity A13 for ASD relay pin 85
- 5 - 18 gauge RD/YL wire from PDC cavity A15 for ASD relay pin 30
- 6 - Splice Repair (3 wires)
- 7 - 18 gauge RD/YL wire from PDC fuse #9 for ASD power

- 
14. Strip approximately 0.25 inches of insulation from both ends of the RD/YL wire cut in Step #13.
  15. Splice the two RD/YL wires to the one remaining PK/WT wire (2 inch lead at A13) together (Fig. 4). **Be sure to slide shrink tube over wire before crimping.** Splice the wires with kit p/n 05018395AA.
  16. After both splices are complete, solder crimp splices with non-acid core solder.
  17. Slide shrink tube over soldered splices and shrink with a heat gun until sealant is visible on both ends of the splice (Fig. 4).
