SERVICE BULLETIN

NUMBER: 09-010-04 REV. A

4.0L Engine - Dirt And Debris Accumulation At Rear Main Seal

1997 - 2005 (TJ) Wrangler

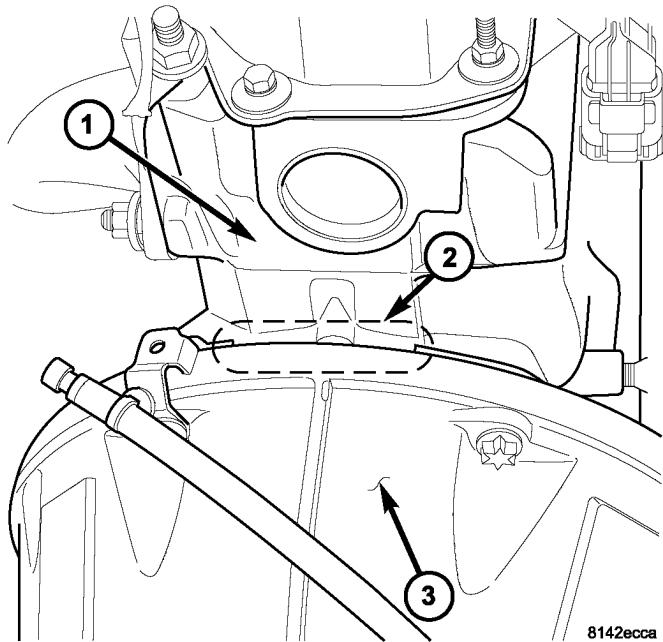
**Fig. 1 LOCATION OF ADAPTER OPENING**

A spacer plate is used to mate the transmission bellhousing to the back of the engine. The spacer plate has a slot machined into it at the 12 o'clock position. A small opening may occur as a result of the spacer slot when the spacer is mated between the engine and transmission bellhousing. The narrow spacer opening at the top of the transmission bellhousing may allow small size debris to enter the bellhousing and accumulate around the outside of the rear main engine seal. If debris accumulation becomes significant, damage to the rear main seal may occur.

- 1 - BACK OF ENGINE
2 - LOCATION OF NARROW OPENING DUE TO SLOT IN ADAPTER PLATE
3 - TOP OF BELLHOUSING - MANUAL TRANSMISSION

1. With the ignition switch in the off position, raise the vehicle hood and make sure the engine and exhaust manifold are not hot to the touch (Fig. 1).
2. Locate the narrow opening created by the spacer plate. The spacer opening can be viewed when looking towards the rear of the engine and top of the transmission bellhousing from the drivers side of the engine (Fig. 2).
3. Thoroughly clean the immediate area around the spacer opening with throttle body cleaner, p/n 04897156AA. Allow cleaner to dry.
4. Apply a sufficient amount of RTV over the spacer opening. Verify that the spacer opening is completely sealed off by the RTV.
5. Lower and secure vehicle hood.

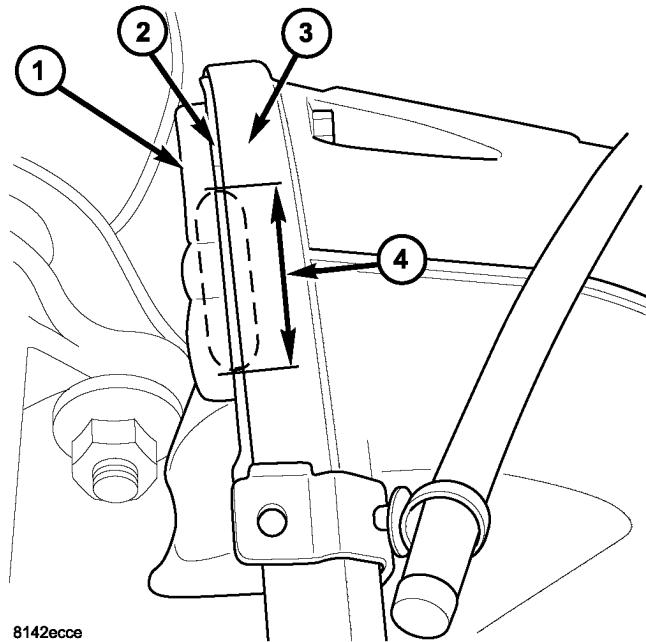
Fig. 2 ADAPTER OPENING DETAIL

- 1 - BACK OF ENGINE
 - 2 - ADAPTER PLATE
 - 3 - BELLHOUSING - MANUAL TRANSMISSION
 - 4 - ADAPTER PLATE OPENING - APPLY SEALER HERE
-
