**NUMBER:** 18-037-05

**GROUP:** Vehicle Performance

**DATE:** October 20, 2005

Flash Programming Failure Recovery Using DRBIII®

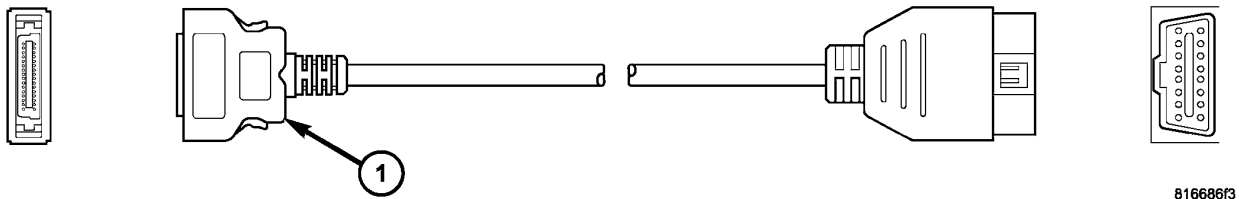
**Fig. 1 CH7000A CABLE**

1 - DRBIII® CONNECTOR (RED)

**Failure to use the new cable or to use a damaged cable often results in failed flash reprogramming sessions.**

CH7000A is the required cable for ALL flash reprogramming. The older CH7000 cable can be used for diagnostics **ONLY**. One (1) cable was shipped to all dealerships.

**NOTE: Consider all cables wear items. Always inspect for worn, damaged cables, connectors that are damaged or do not lock securely, and all mating connections including checking for corrosion on the pins. REPLACE ALL suspect cables. Do not use worn or damaged cables when flash reprogramming.**

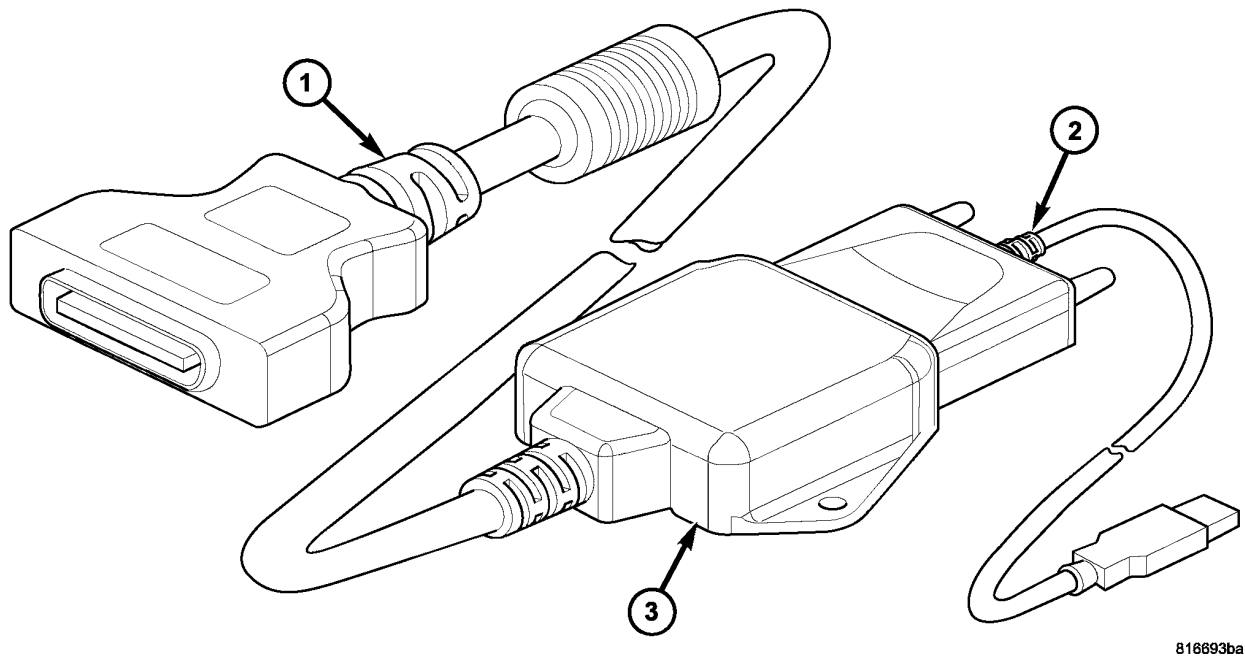
**Fig. 2 CH2002 ASSEMBLY**

- 1 - CH7035B
- 2 - CHGPIB-B
- 3 - CH7036
